National Register of Historic Places Registration Form

1. Name of Property	
historic name Central Avenue School	
other names/site number	095-015-49088
2. Location	
street & number 2120 Central Avenue	N/A not for publication
city or town Anderson	N/A □vicinity
state Indiana code IN county Ma	adison code 095 zip code 46016

Section _7	Page _1 Central Avenue School
	name of property
	Madison County, Indiana
	county and State
	Indiana's Public Common and High Schools
	name of multiple property listing

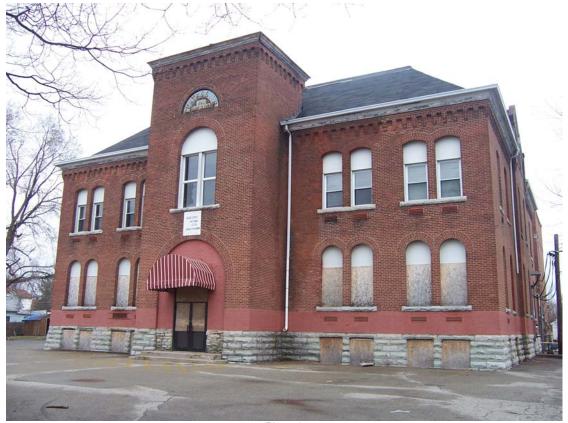
Photo 1

The west facade faces Central Avenue and is composed of three parts (Photo 1). The central 3-story tower projects out approximately eight feet from the front of the building. Its original sharply pitched pyramidal roof was replaced by a flat or very shallow pitched roof prior to 1954. The tower roofline has a metal cornice with corbelled brick accents on all four sides. The main entrance is centered in the tower underneath a large round brick arch. Originally, this arch was open and the main entrance to the school was recessed beneath the arch within the tower. The original arch was two brick faces tall. A set of steps starting at the front edge of the tower carried students up to the front doors at the first floor level.

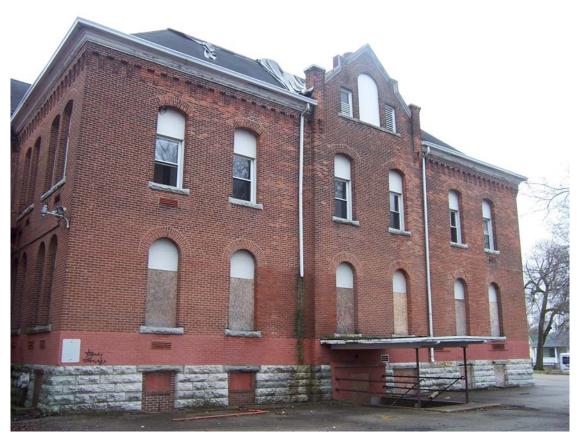
Photo 2

The north side of the 1891 building is divided into three sections (Photo 2). The center section projects approximately 4 inches out from the façade and is capped by a gable at the attic level. The straight line of the gable is broken on each side by a triangular accent. A metal cap along the top of the gable protects the brick edge. The attic is lit by a Palladian window in the gable with a single stone sill across all three. The center one is a round arch opening that is boarded. The shorter side openings have flat arches. The right is infilled with louvers, the left with half glass and half louvers. Chimneys integrated into the brick walls are visible at the roofline on each side of the gable. The chimneys have decorative corbelling where they meet the roofline. The center projection has two window openings on the first and second floors. A basement window is centered under one window bay and a modern door under the other. The steps from the ground level down to the basement door are modern construction with brick walls and poured concrete. The steps are covered by a modern flat roof canopy. Drain pipes extend down this façade on either side of the center section.

The original 1891 rear façade (east) matched the north and south façades in profile and the west façade in layout of the openings. However, the center projected slightly farther out than those on the north and south facades (Photo 3). Decorative details on the rear of the 1891 building including the roofline corbelling match the previous facades (Photos 2&3).

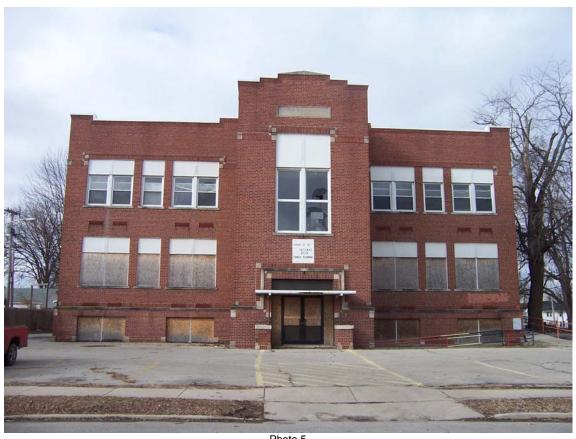
Photo 5

The Fletcher Avenue (east) façade of the 1921 addition has a central, 3-story projecting tower, similar to the Central Avenue façade in layout, but with distinctly different decorative details (Photo 5). The tower has a stepped roofline with concrete cap. The primary 1921 entrance into the school is centered in the tower (Photo 8). The original doors were replaced with double aluminum frame doors. A flat roof canopy is attached to the façade just above the door header. The original transom opening remains in place above the canopy. The doorway is accented along the sides and across the top with decorative brickwork that connects to the basement level stringcourse. Around the doorway, the stringcourse is stepped with varying configurations of soldier rows of bricks and a concrete cap. Like the windows, the corners of the doorway have square accents. The modern canopy is supported by two cast iron columns resting on half walls. The half

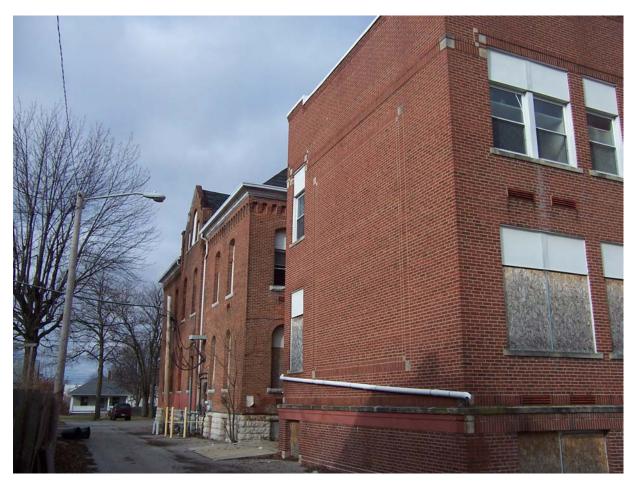
Photo 6

The south side of the 1891 building is identical to the north except for the vents and the basement door (Photo 6). The vents vary based on the mechanicals and the south side has no basement door. There are five single basement openings. The middle opening is infilled with concrete block. The remaining four are boarded up with plywood. Various conduits and electric meters serving the school building are mounted to this façade.

The north façade of the addition has two windows, one on the 1^{st} and 2^{nd} floors, near the northwest corner. On the south side, the addition has three windows in the southwest corner of the main body, one on each floor (Photo 6).

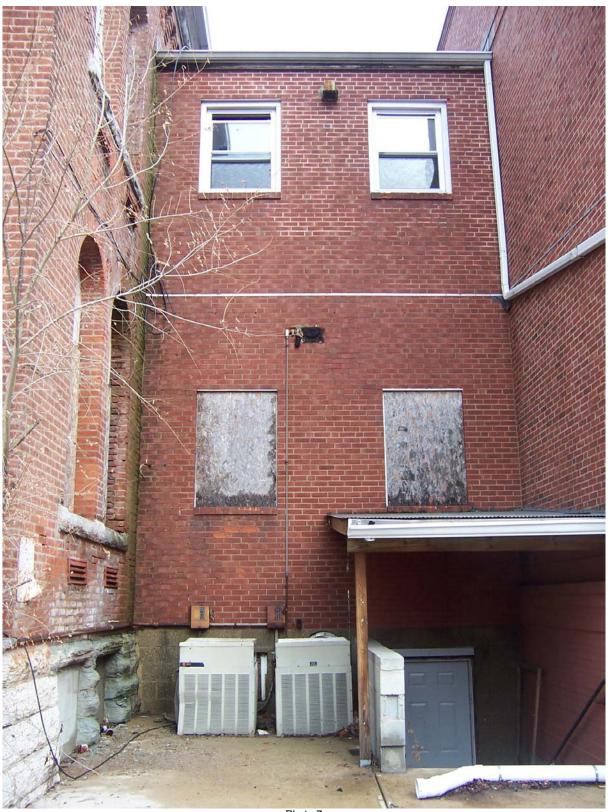
Photo 7

In 1949, a small addition was constructed along the south side of the narrow section of the 1921 addition (Photo 7). The foundation of this addition is concrete block and the brick is newer and slightly different in color. The four window openings are the smallest in the building. A basement door and steps were constructed into this addition with concrete block. A sloping canopy attached to the façade over the door and along one side is wood construction. The HVAC units are located next to the door. Although this addition is small and not visible from either primary façade, it obscures one bay of window openings on the rear of the 1891 building.

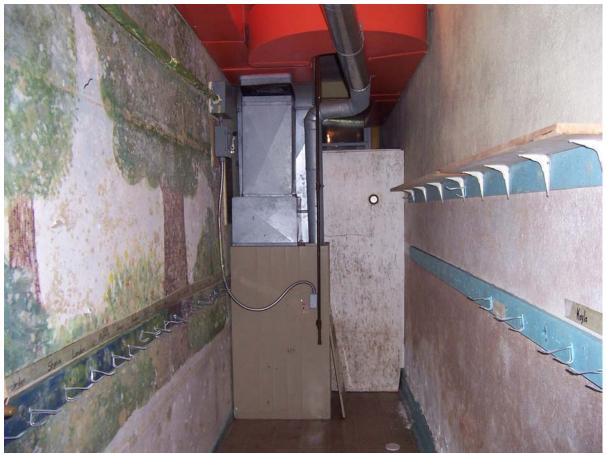
Photo 10

The north classroom has chalkboards stretched across the north and south walls. The west wall has a small bulletin board. Both the classroom and storage room have deep baseboards. The narrow storage space has wall murals, mechanicals and built-in cabinets on one end (Photo 10).

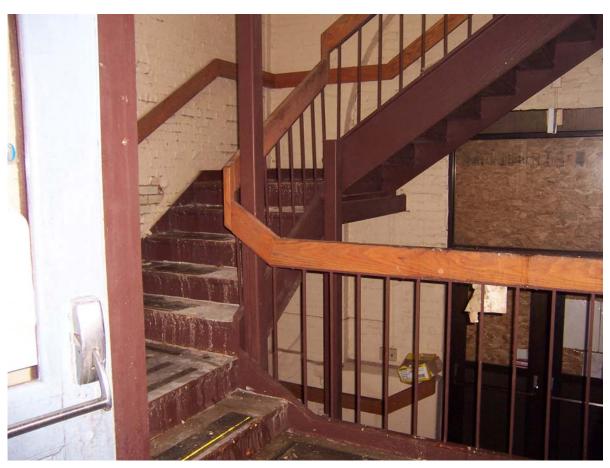
Photo 11

The main entrance on the west end opens into the stairwell at a landing between the first and second floors. This stairwell is located within the tower(Photo 11). It is a later alteration, possibly part of the 1921 or 1949 additions. The original entry was recessed underneath the brick arch on the exterior façade. The doors were at the top of a wide set of steps that ended at the first floor. The existing stairs circle around the stairwell from the basement up to the second floor. The stairs are supported by a modern concrete block foundation at the basement level. On the east end in the 1921 tower, the entrance opens into the stairwell between the basement and first floor

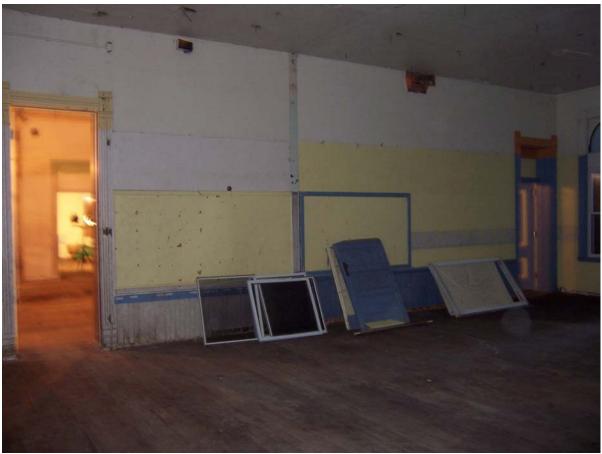
Photo 12

The original northwest classroom in the 1891 building (Photo 12) was subdivided by modern walls leaving the original doorways remain intact. A corner cabinet is intact in the southeast corner. The trim surrounding all the 1891 corner cabinets is fluted with corner medallions to match the window and door trim (Photo 25). None of the original doors to these cabinets remain. The original east and south walls have intact chalkboards with beadboard (Photo 12).

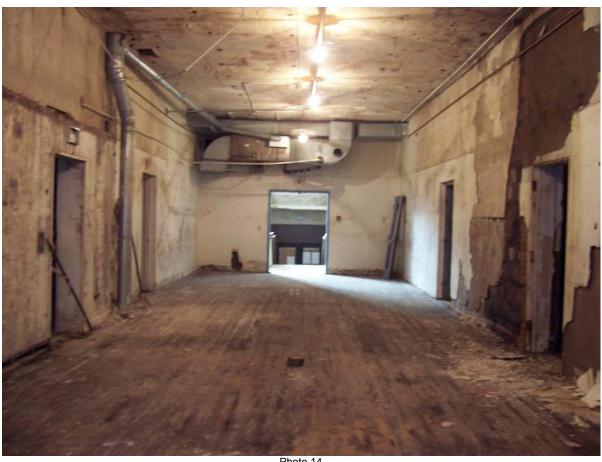
Photo 14

In 1921, the hallway was extended east into the new addition (Photo 14). The north wall of this area has an exterior entrance and the south wall has a door into the 1949 addition. The 1949 room has modern finishes, but is in very poor condition due to a roof leak.

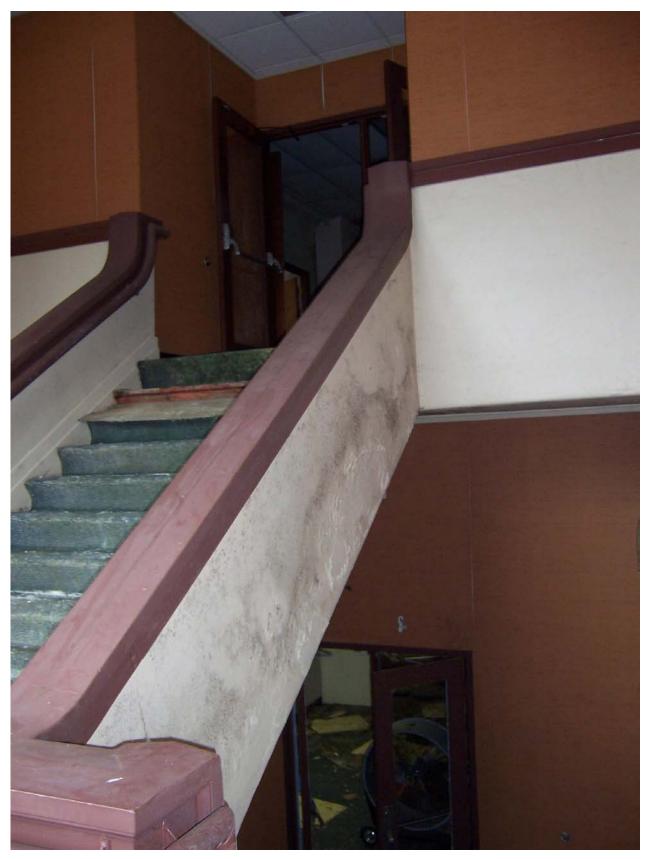
1921 The 1921 central hallway is slightly narrower than the 1891 hallway and does not have the ornate door trim nor the beadboard trim (Photo 14). At the end of the 1921 hallway is a glass wall with a set of modern double doors opening into the stairwell in the 1921 tower (Photo 16). The stairwell is constructed in a double return layout. It is original to the 1921 construction with plaster walls and wide wood cap. Rounded wood handrails are attached to both sides of the stair. Steel and glass exterior doors are located at a landing between the 1st floor and basement.

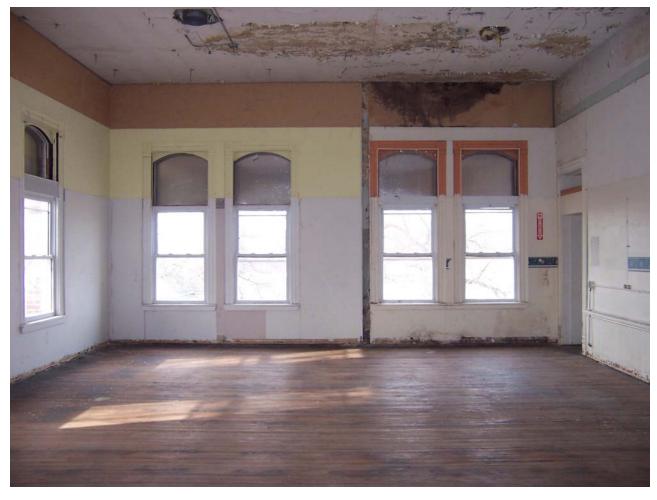
Photo 18

The southwest classroom (Photo 18) retains several chalkboards and sections of beadboard on the original north and east walls, as well as the door and window trim. This classroom has two intact doorways with trim and transom openings. The original doors were replaced.

The 1891 interior is more elaborate than the 1921 with fluted door and window trim and corner modillions (Photos 18 & 27). Beadboard and decorative trim accent the lower fourth of the hallway walls and many classroom walls (Photos 19 & 25). 1921 trim consists primarily of simple door trim, chair rails and baseboards (Photo 23). Many chalkboards, storage closets and built-in cabinets are intact (Photos 15,19,20,24 & 25).

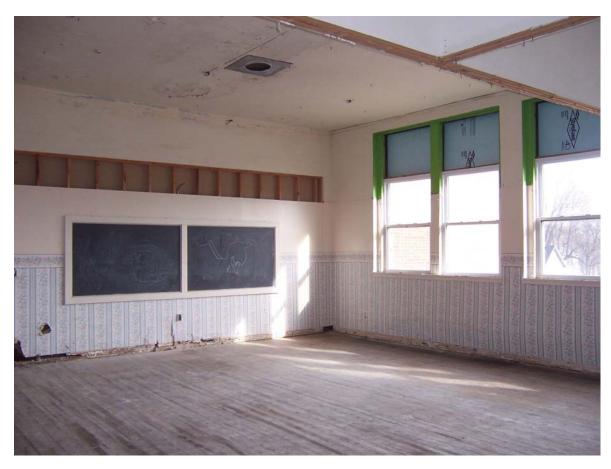
Photo 19

The southeast classroom (Photo 19) was divided into five spaces with a narrow hallway. These walls were constructed over the long spans of chalkboards and beadboard paneling. Part of the wall between the southeast and southwest classrooms was removed and a column added for support. The doorway and trim between the classrooms remains intact.

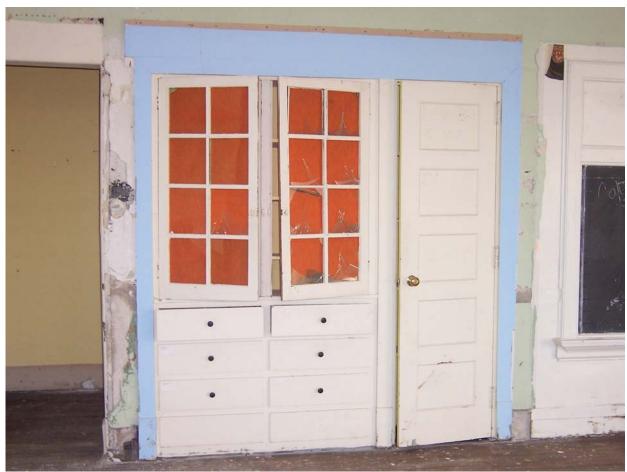
Photo 24

The built-ins in each room consist of a closet, two feet wide with a five-panel door (Photo 24). The cabinet has four shelves on the top. In the north room, these shelves are open with two sets drawers in the bottom half (Photo 15). In the south room, the top and bottom have shelves with replacement doors on top. The original hinge indentations are visible in both.

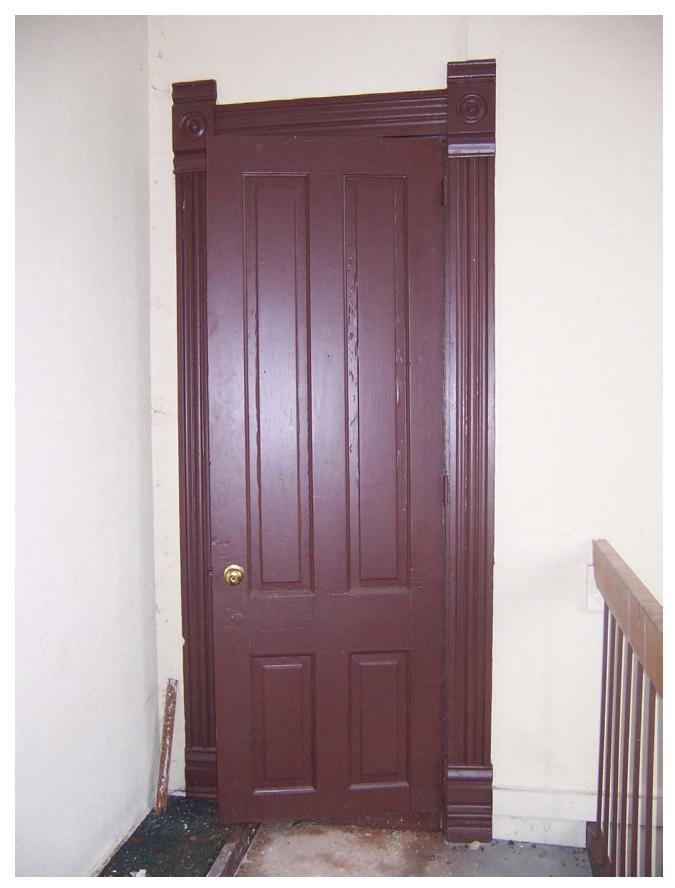
Photo 27

Central Avenue School Madison County, Indiana Carol Ann Schweikert Indiana Division of Historic Preservation & Archaeology 1891 - 2nd floor - Attic door in stairhall, camera looking south #27 August 23, 2006
